FLIGHT MEASUREMENTS OF LATERAL AND DIRECTIONAL  
STABILITY AND CONTROL CHARACTERISTICS  
OF THE GRUMMAN F8F-1 AIRPLANE

TED NO. NACA 2379

H. L. Crane and J. P. Reeder

Langley Memorial Aeronautical Laboratory  
Langley Field, Va.

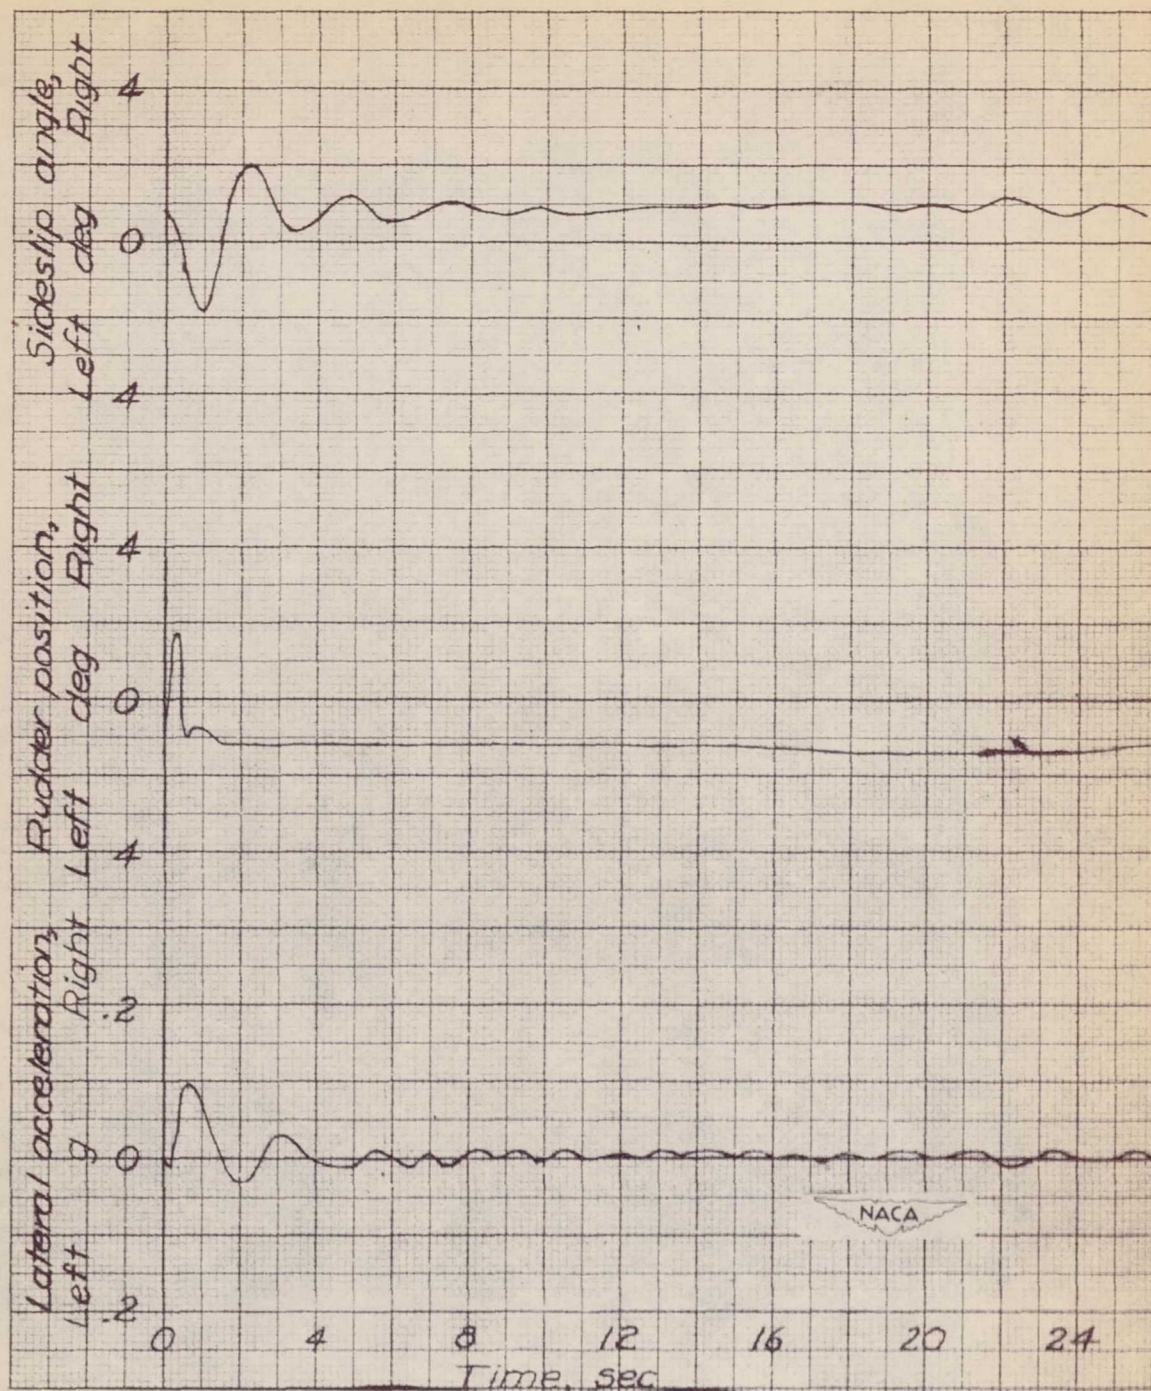
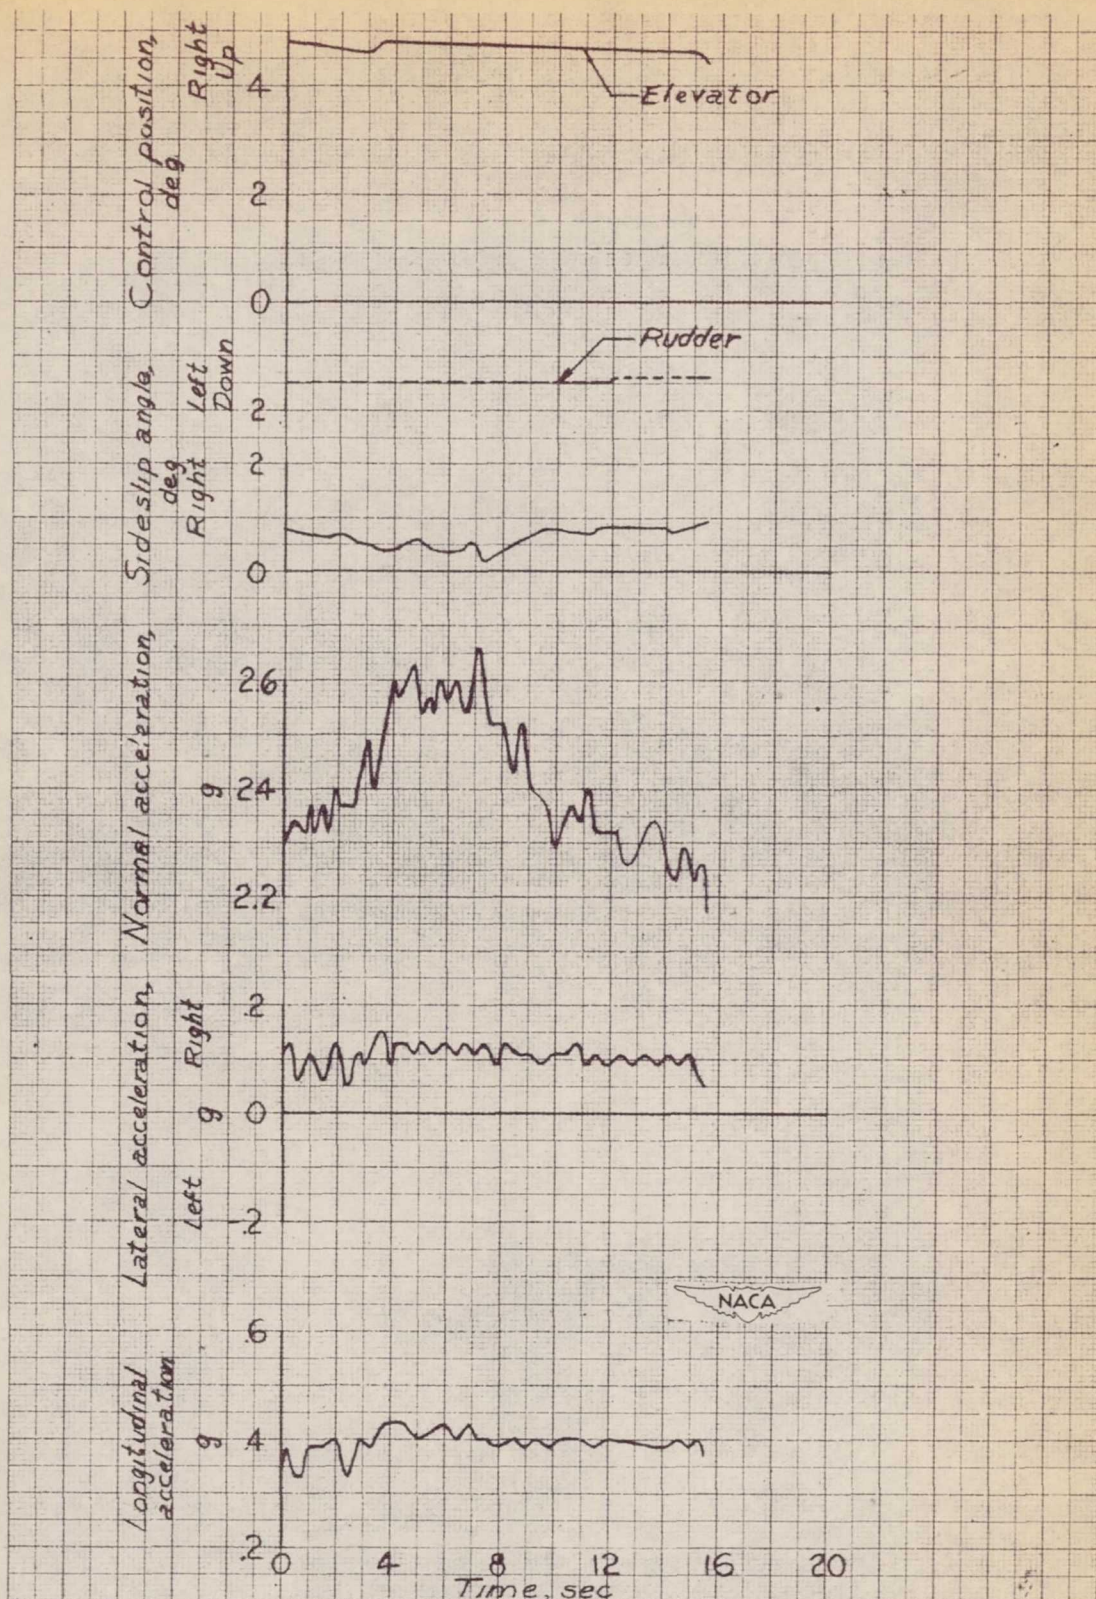
(a) Induced by a rudder kick at 250 miles per hour with fuselage tank approximately half full and an empty belly tank installed.

Figure 10.- Time histories of lateral oscillations in smooth air due to fuel sloshing, F8F-1 airplane with tail configuration 3.

(b) Induced by rapid turn entry at 250 miles per hour with fuselage tank approximately half full.

rudder kick and was obtained with an empty belly tank installed and with the fuselage tank approximately half full (at a speed of 250 miles per hour). In some cases the oscillation was noted mainly in terms of lateral acceleration (fig. 10(a)) and in other cases the oscillation occurred in the three measured components of acceleration (fig. 10(b))

Variations of propeller pitch and fuel sloshing were considered as possible causes of the oscillation. The first possibility was eliminated by obtaining the oscillation with the propeller set against the low-pitch stops. It was then found that the oscillation could be induced by a maneuver such as an abrupt turn entry. During the oscillation there was a fluctuation of the fuel gage which led to the conclusion that the oscillation was due to fuel sloshing.

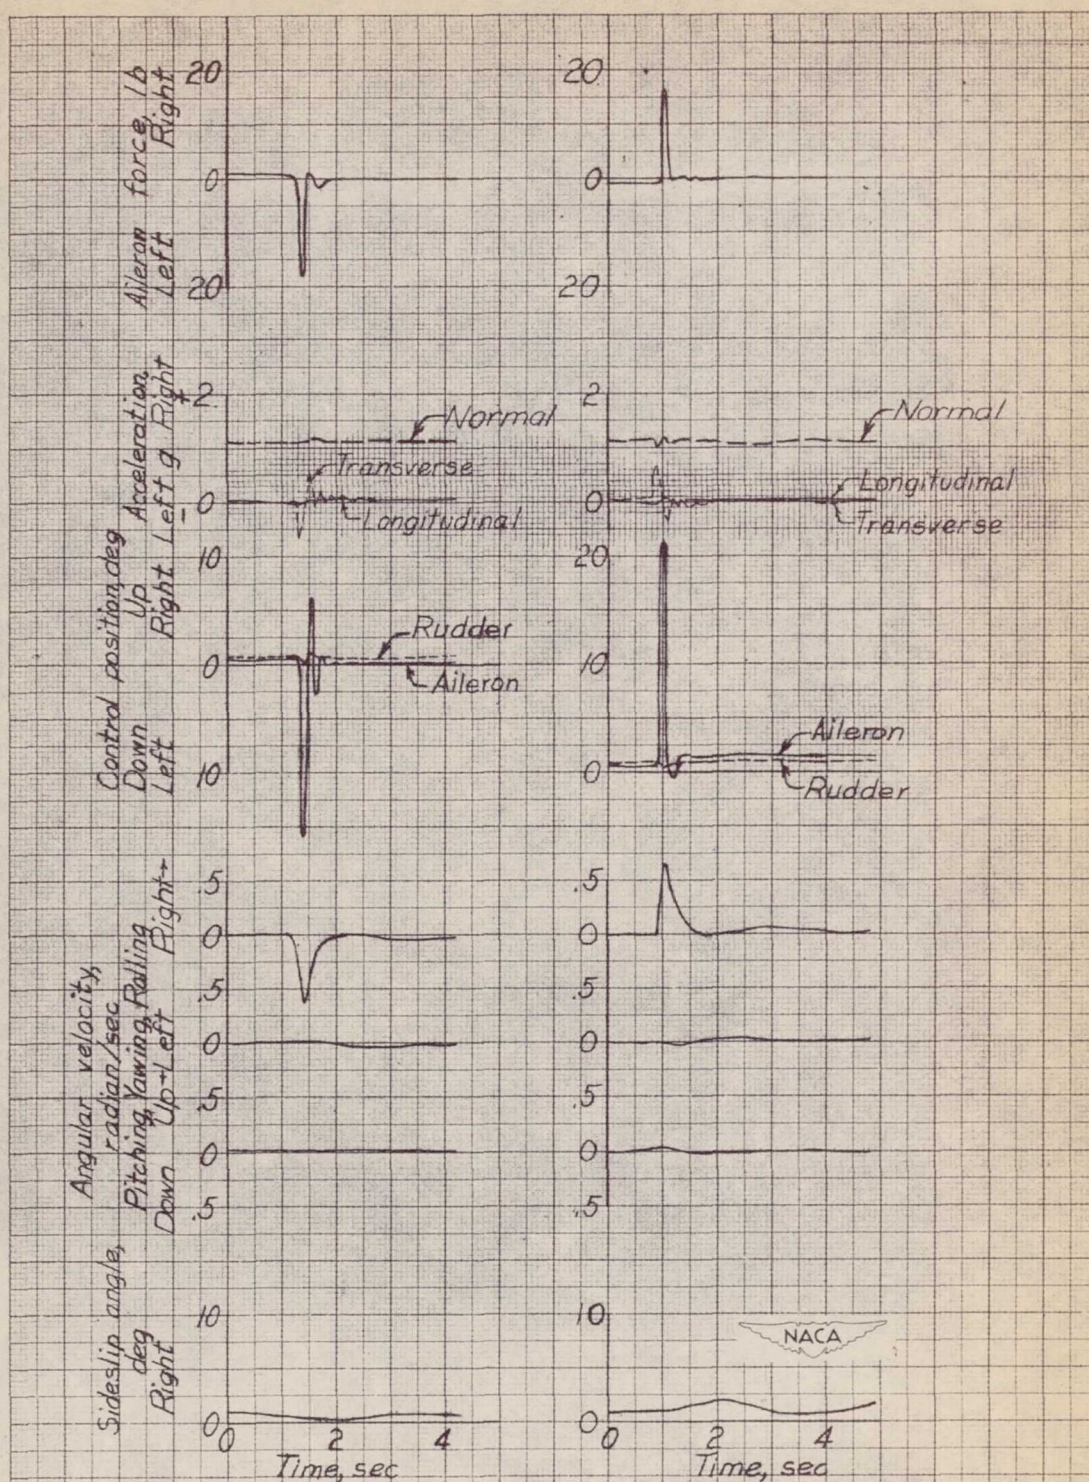
Figure 11.- Time histories of oscillation produced by abrupt left and right aileron deflection and release, F8F-1 airplane with tail configuration 1; belly tank installed. (290 mph)

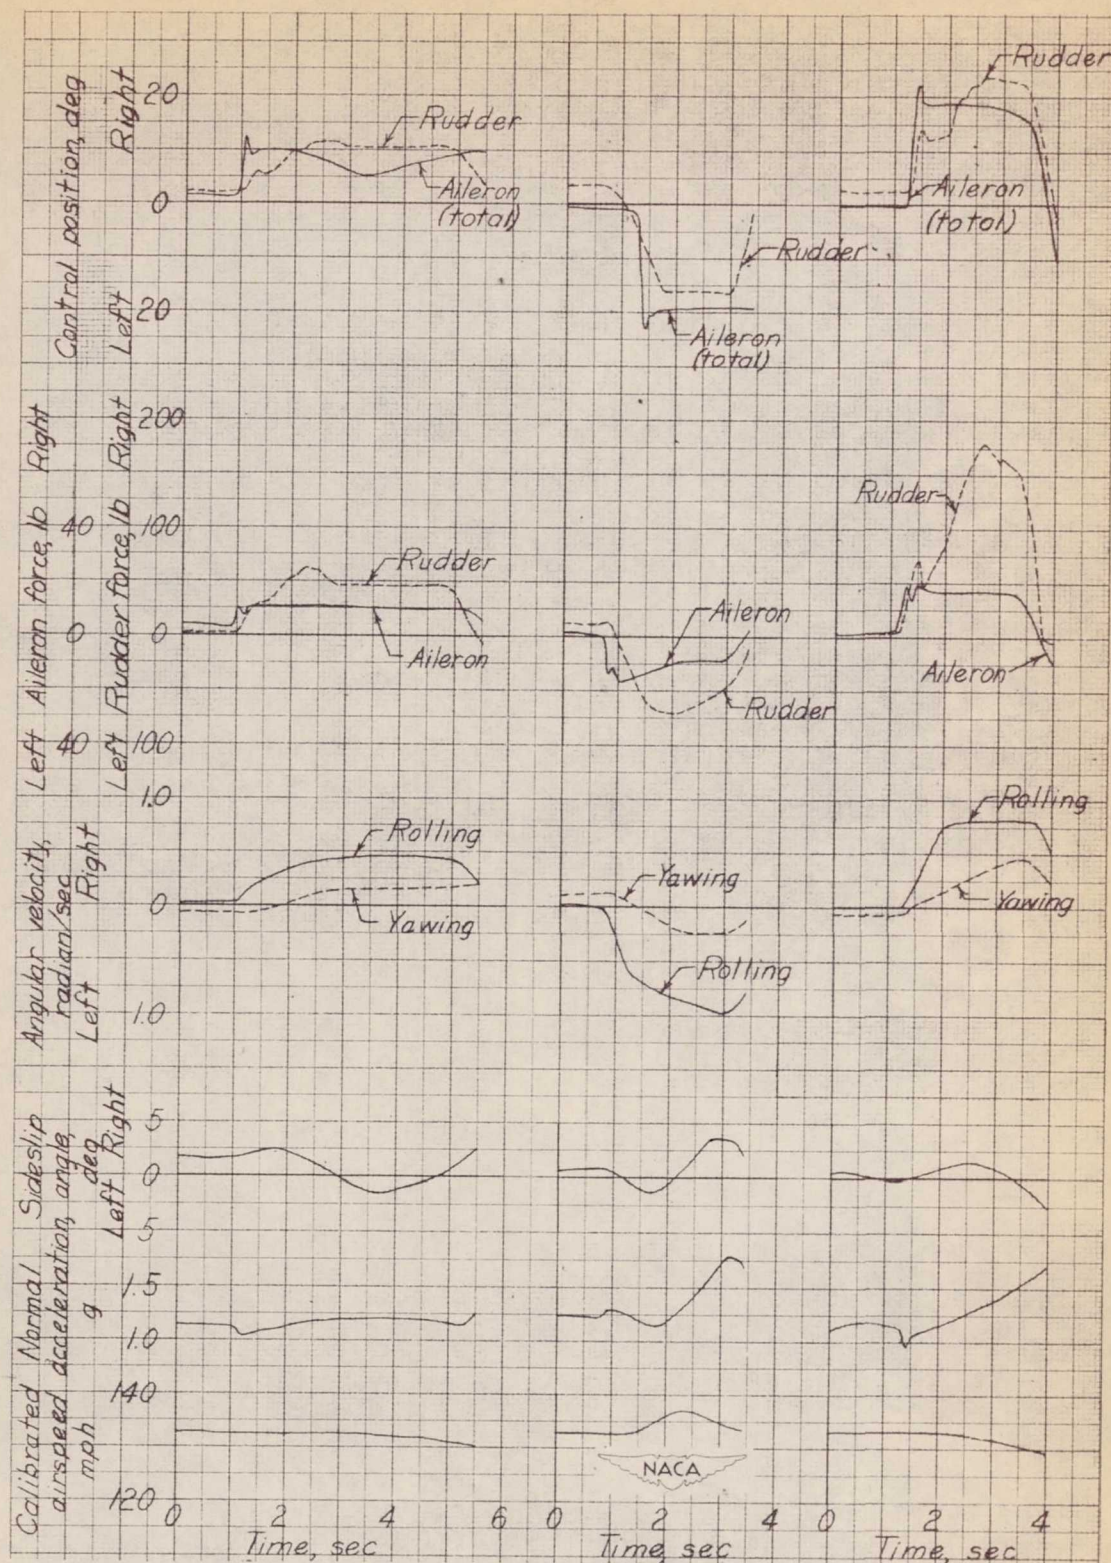
Figure 12.- Time histories of coordinated rolls out of  $45^\circ$  banked turns at 135 miles per hour in the clean condition with power for level flight (15 in. Hg at 2300 rpm) at 5000 feet, F8F-1 airplane with tail configuration 1, without belly tank.

The sideslip due to deflection of the ailerons with rudder fixed and the rudder required to overcome adverse aileron yaw were measured in rolls out of  $45^\circ$  banked turns. Figure 12 contains time histories of rolls out of turns which were made by applying approximately two-thirds aileron deflection at 5000 feet in the clean condition with belly tank off using power for level flight at 135 miles per hour. In these rolls the pilot attempted to coordinate the rudder and ailerons to maintain zero sideslip. Similar roll-outs made with full aileron and rudder deflection showed that there was a little more than sufficient rudder control to overcome the yawing moment due to ailerons. The rudder control force did not exceed 180 pounds during these maneuvers.

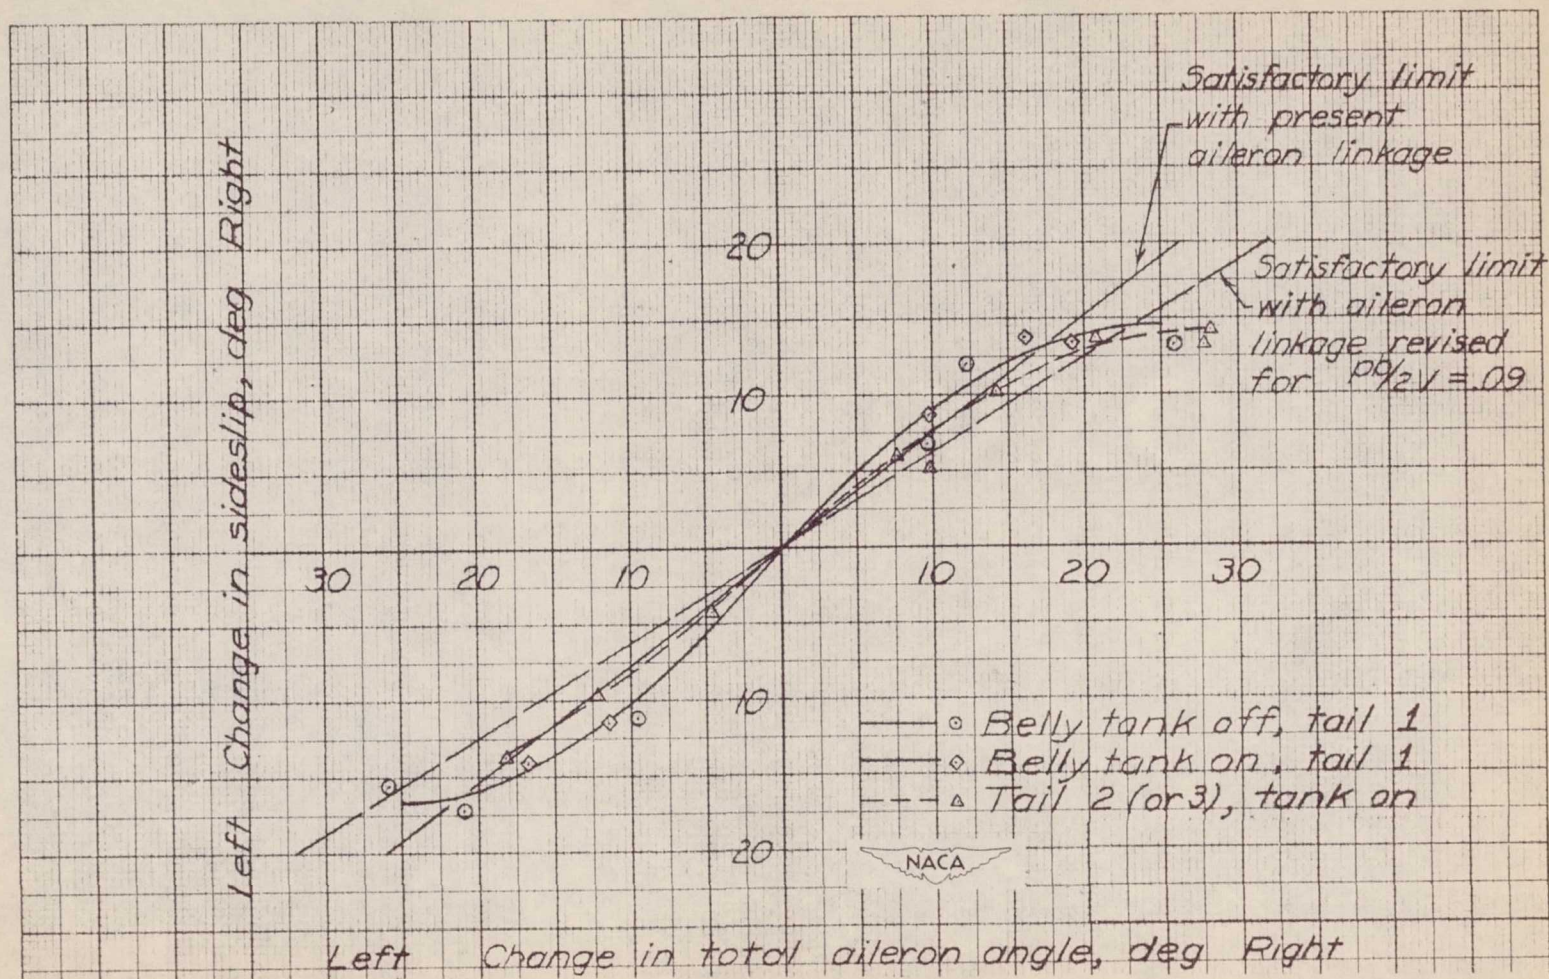
Figure 13.- Rudder-fixed rolls out of 45 degree banked turns at 135 miles per hour in the clean condition with power for level flight (15 in. Hg at 2300 rpm) at 5000 feet, F8F-1 airplane.

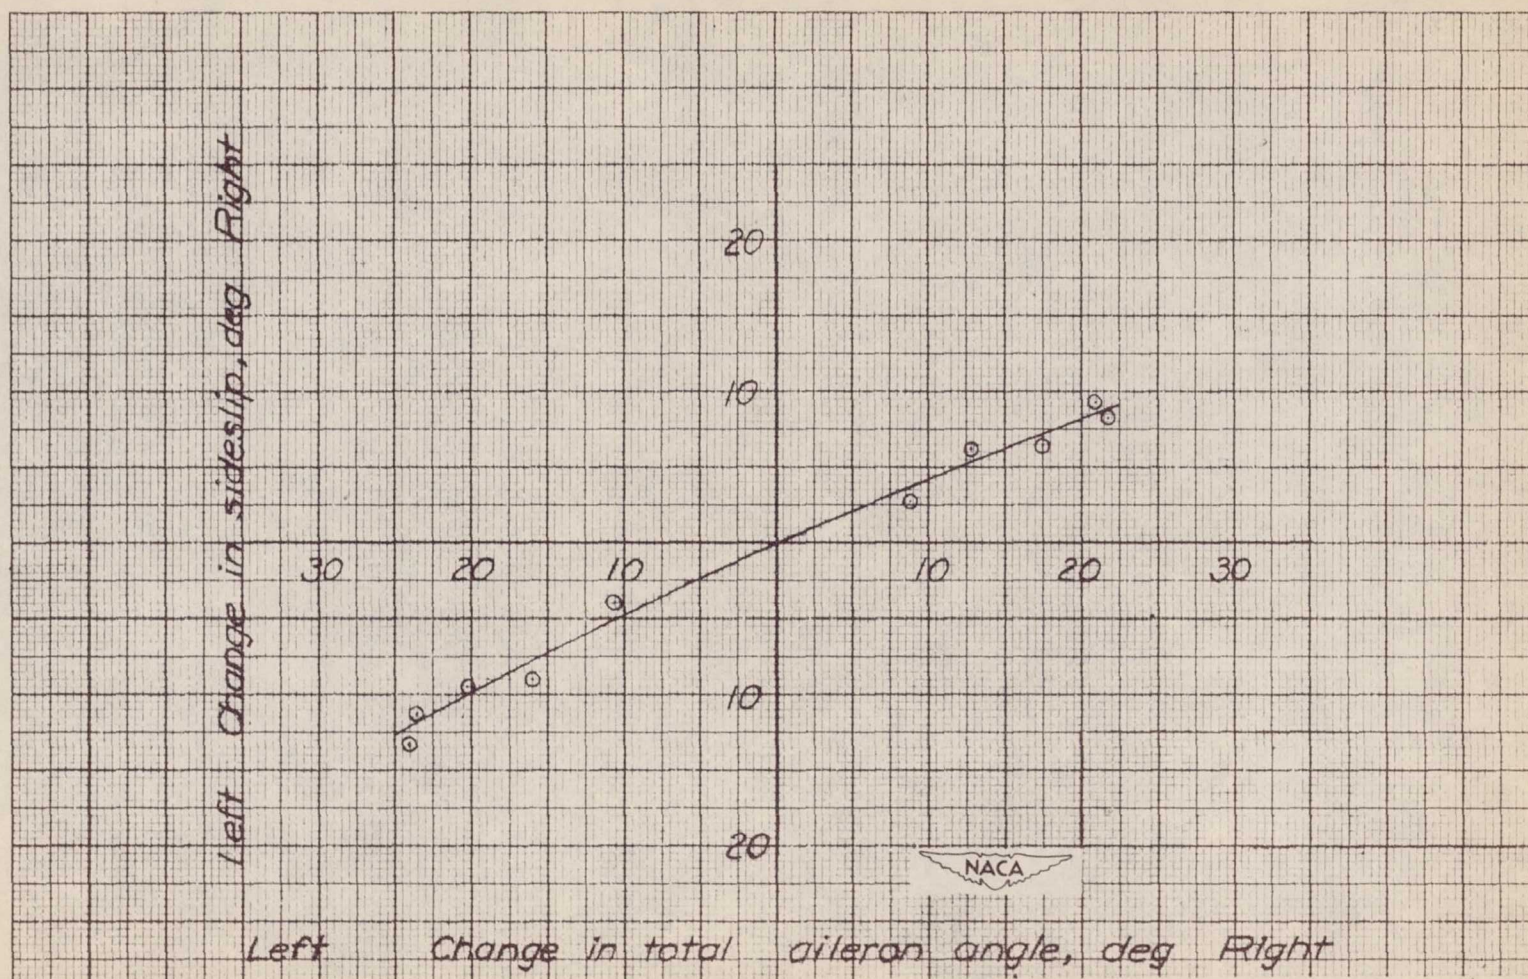
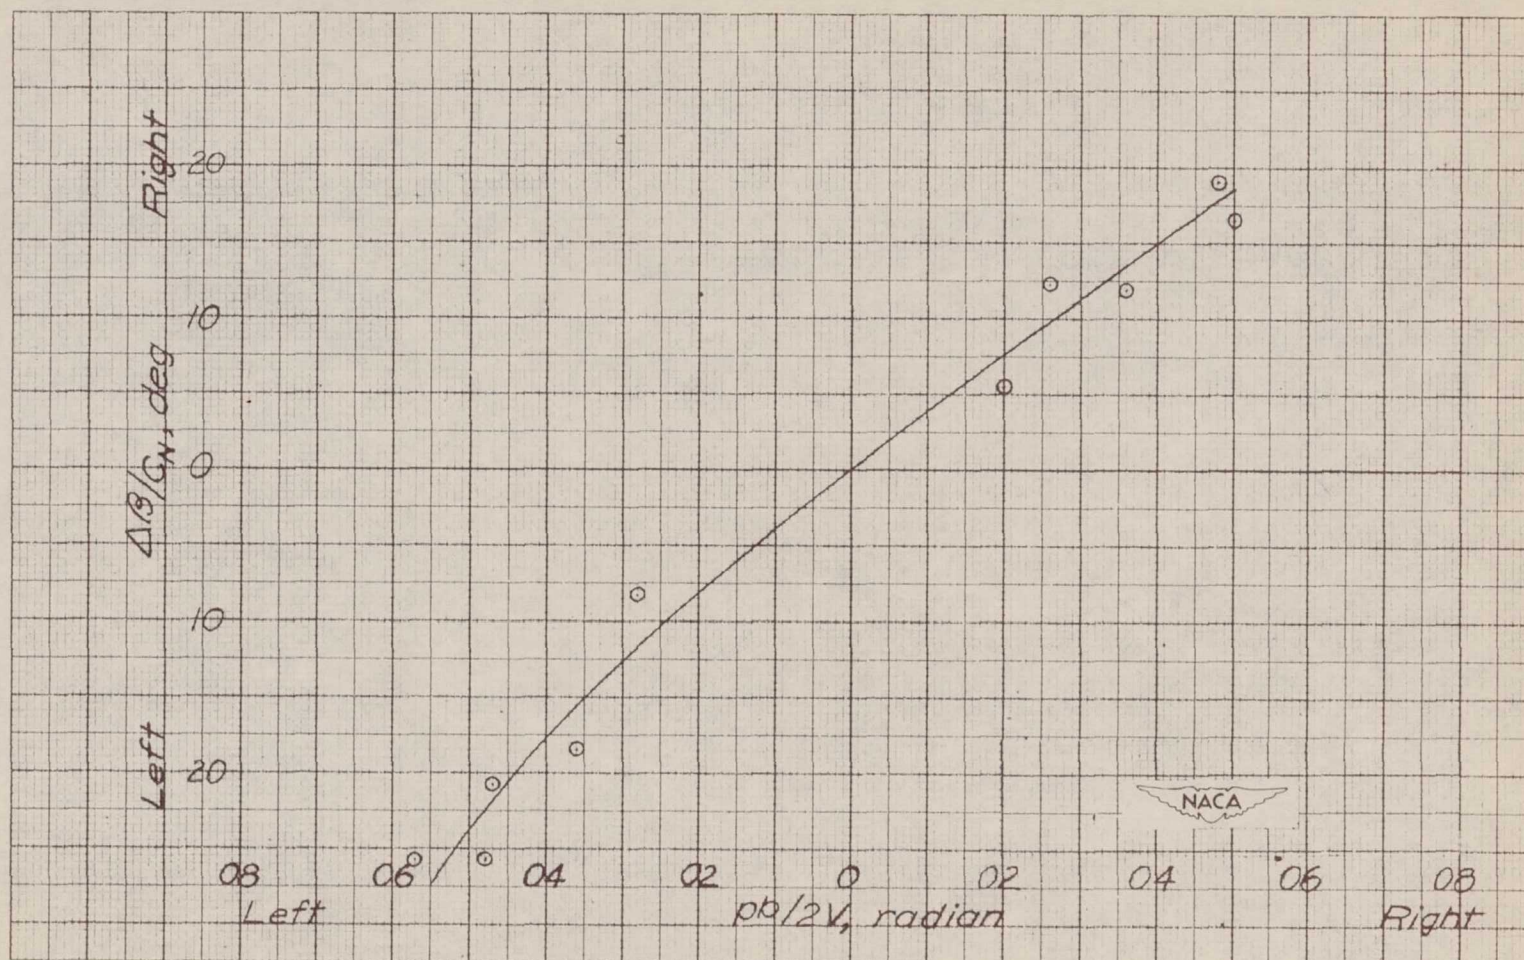
(a) Plot of change in sideslip angle against change in total aileron angle.

Figure 14.- Rudder-fixed rolls out of 3 g turns at 290 miles per hour in the rated-power clean condition (41 in. Hg at 2600 rpm) without belly tank, F8F-1 airplane with tail configuration 1.

(b) Plot of change in sideslip angle divided by normal force coefficient against maximum  $pb/2V$ .

Rudder-fixed rolls out of 3g turns at an indicated airspeed of 290 miles per hour at 5000 feet were made in the rated power, clean condition with tail configuration 1. The data obtained are plotted in figure 14. In these maneuvers the pilot attempted to maintain a constant acceleration as the airplane rolled. The pitching moments caused by sideslip and by yawing velocity during the roll made it difficult for the pilot to maintain exactly constant acceleration, and as a result the data obtained show some scatter. Figure 14(a) contains a plot of the change in sideslip angle as a function of the change in total aileron angle. In figure 14(b) the same data are plotted in another form as the variation of  $\Delta\beta/C_N$ , the change in sideslip angle divided by the normal-force coefficient, with  $pb/2V$ . Plotting in this form makes possible a comparison of the directional stability of different airplanes without regard to the effect of normal-force coefficient on the change in sideslip angle or to relative aileron size.

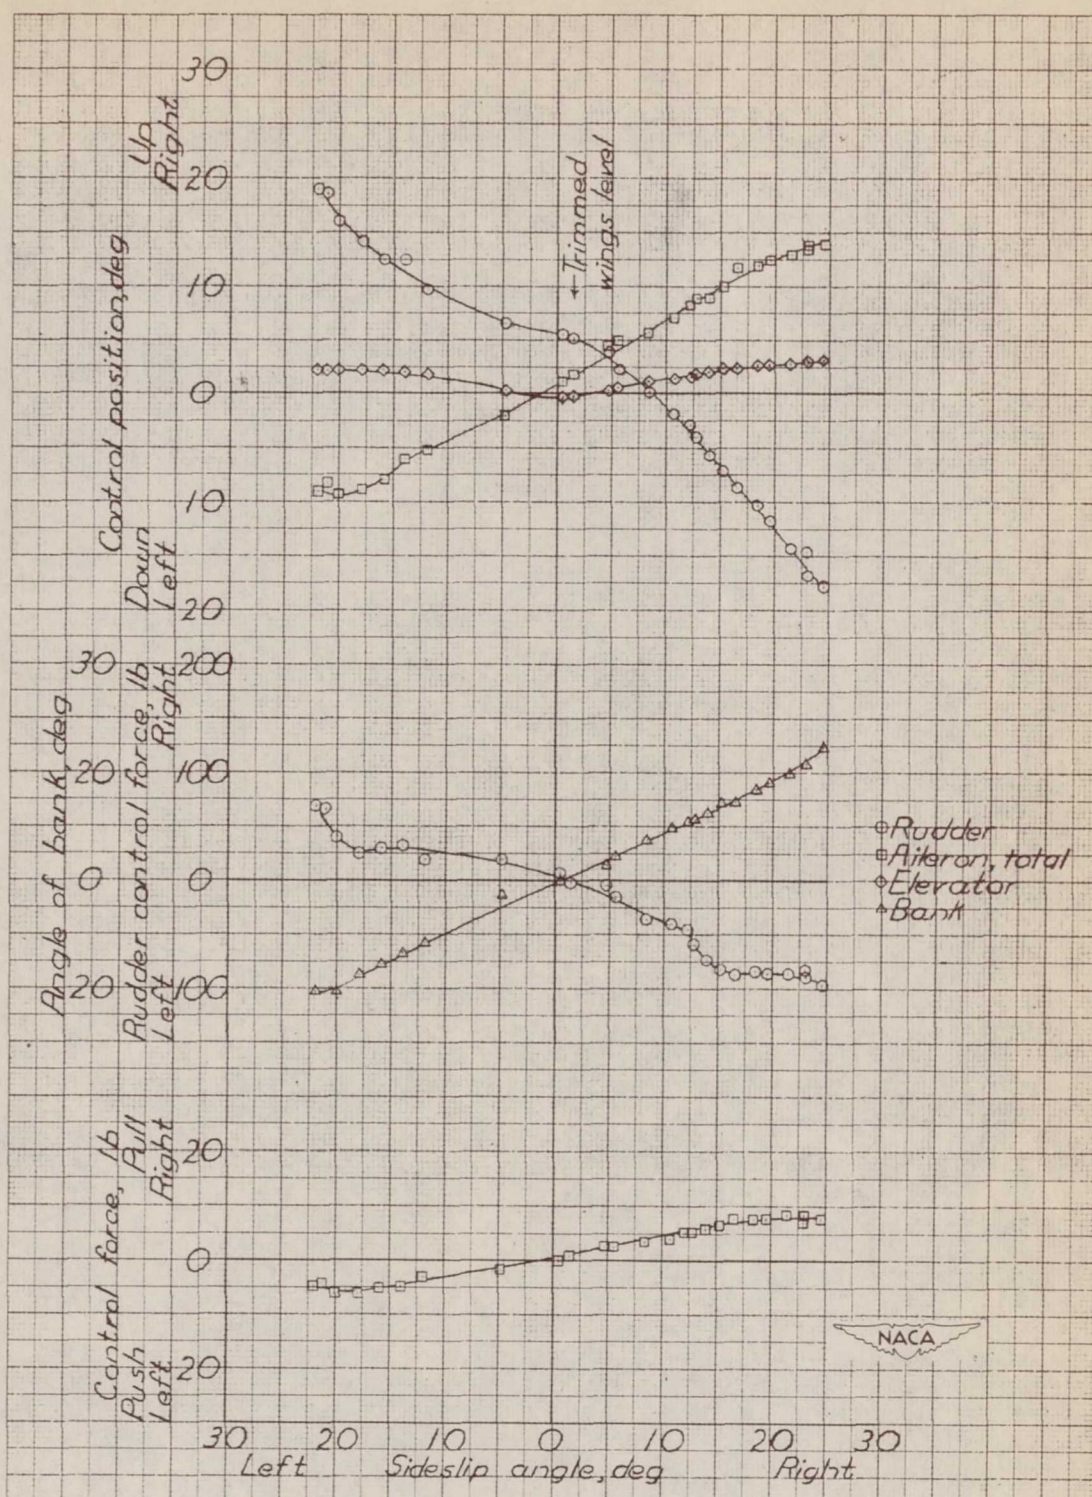
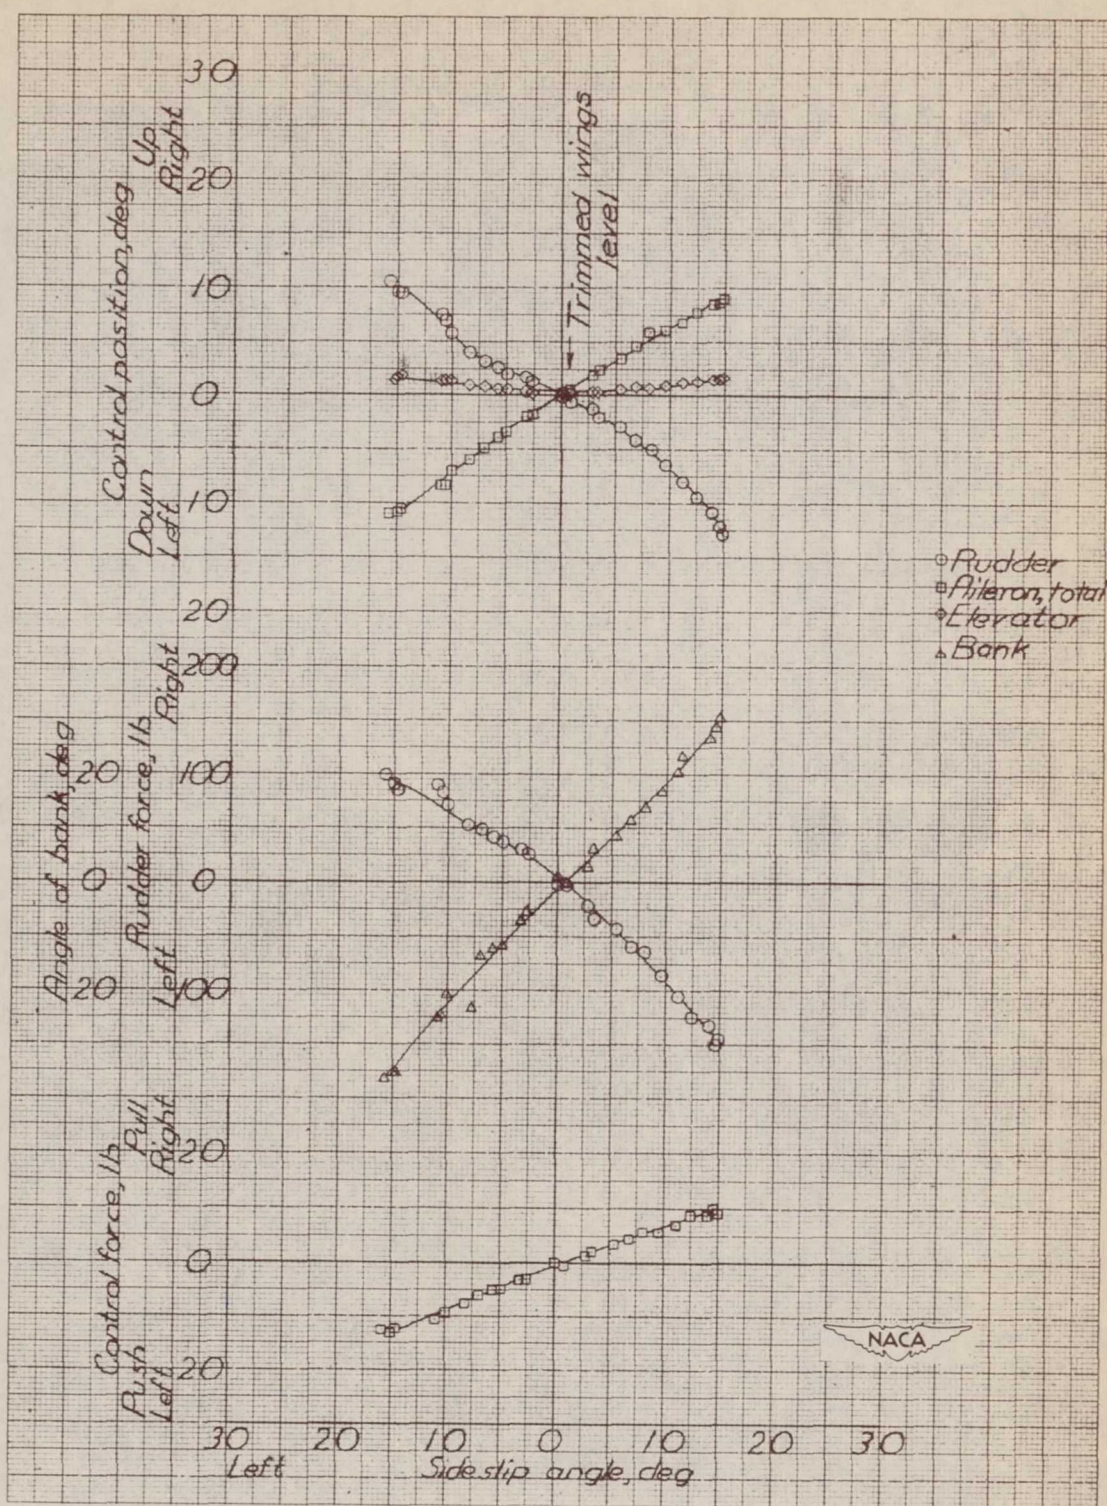
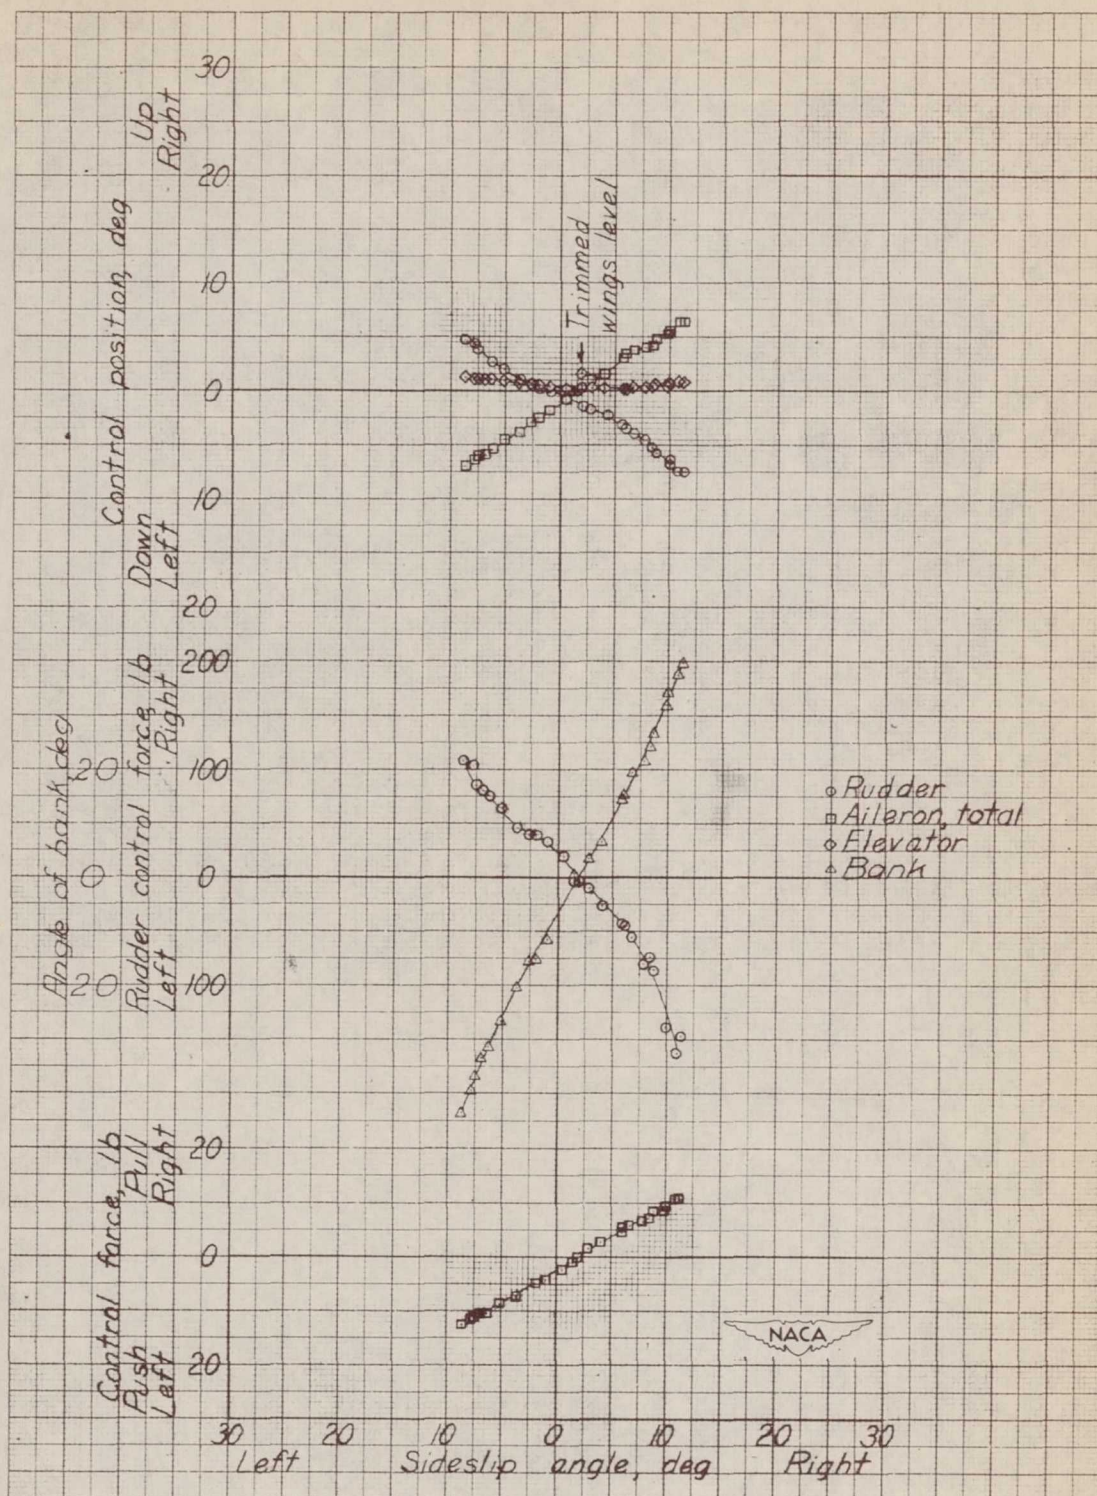
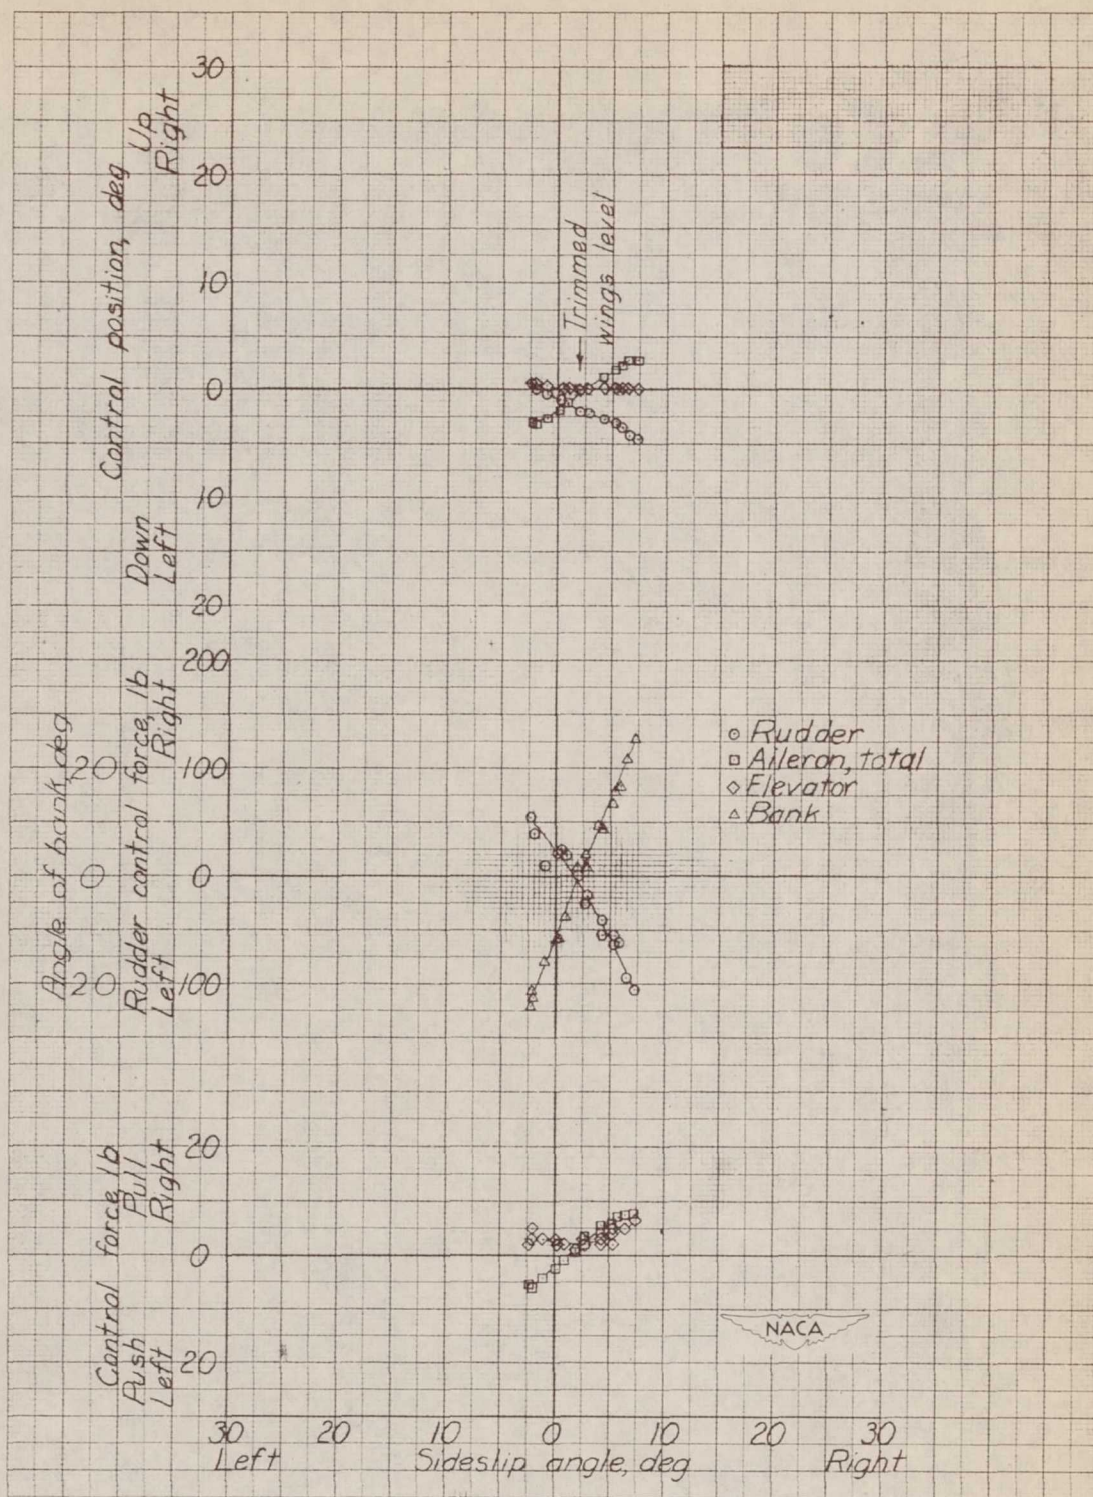
(a) 150 miles per hour, oil cooler open.

Figure 15.- Sideslips in the rated-power, clean condition (41 in. Hg at 2600 rpm) at 5000 feet with belly tank off, cowl closed, canopy closed, F8F-1 airplane with tail configuration 1.

(b) 245 miles per hour, rudder tab  $0.5^\circ$  left, oil cooler closed.

(c) 345 miles per hour, oil cooler closed.

(d) 395 miles per hour, rudder tab  $2.0^{\circ}$  right, oil cooler closed.

Side-force characteristics.- The variation of angle of bank with angle of sideslip, which is a measure of the side-force characteristics, is presented in figures 15 to 21. The requirement that the direction of bank should always be the same as the direction of sideslip was satisfied in all flight conditions at all speeds.
